# ***Stucco***

## ***An investigation of Building Material Failures***

**Building Research Association of New Zealand (BRANZ)**

In conjunction with the requirements of **BBSc 442 Building Materials Performance**  
Victoria University of Wellington School of Architecture and Design

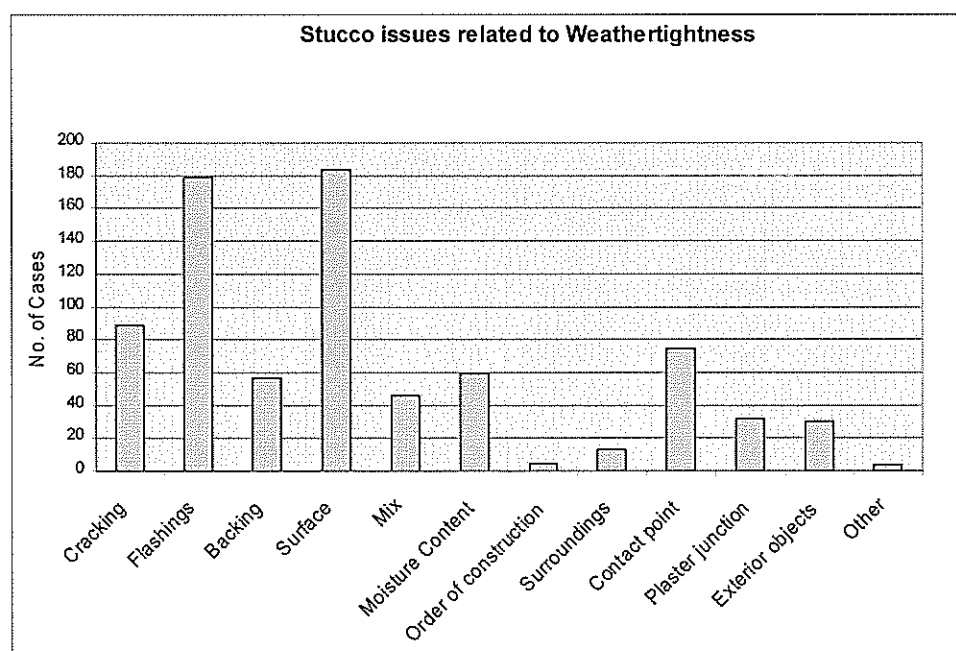
Figure 1.01 Stucco issues related to weathertightness

The BRANZ Site Visit Database (BRANZ dBase 1994-2001) was used to provide the dataset of stucco related weathertightness building failures. An e-matrix was generated to provide a means of assessing the issues associated with stucco failure and to allow a graphical representation of the data to be generated for further analysis. This also allowed more specific analysis (sub-issues) to be conducted from each of these issues. The results obtained highlight the main issues associated with the failures recorded (Figure1.01).

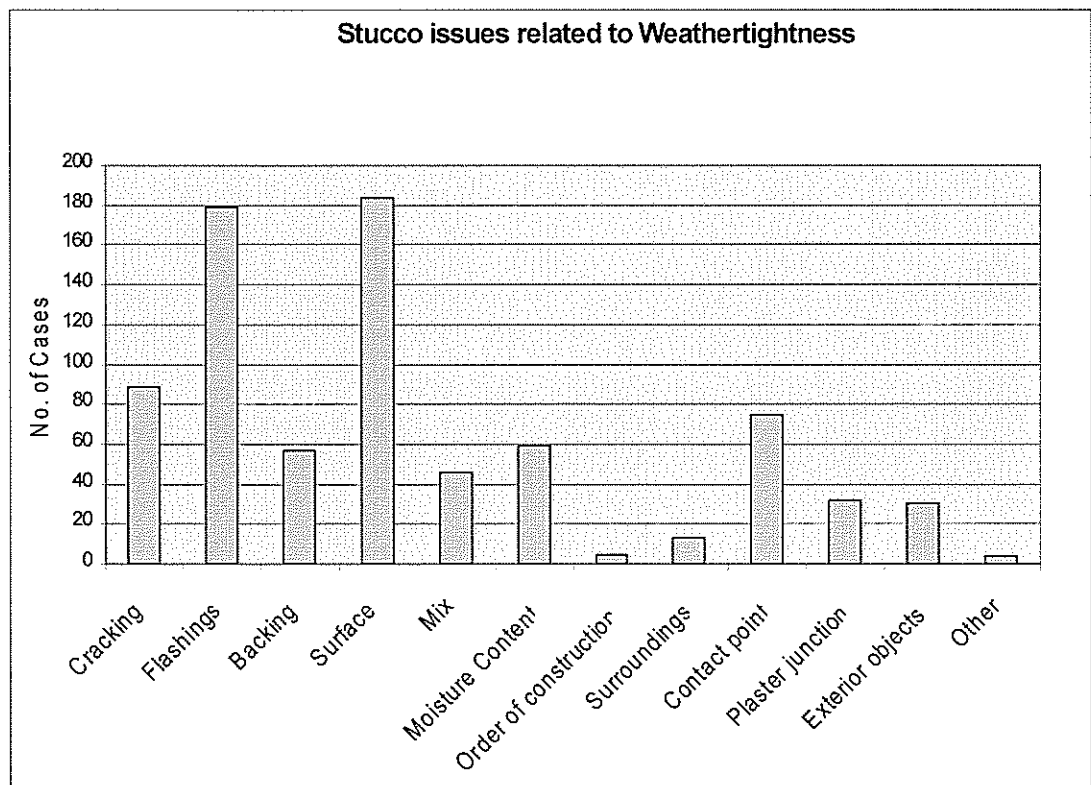
Figure 4.01 Stucco issues related to weathertightness

Figure 4.01 indicates the number of stucco issues related to weathertightness derived from the e-matrix.

The graphic presentation allows a quick and easy way of assessing where the most predominant issues of stucco cladding failure are associated. From Figure 4.01 above it can identified that the area of most concern is that of the surface. The following table, ranked from most frequent to least, will assist in providing a summary of issues.

Table 4.02 indicates that nearly half of all the issues noted in respect to stucco cladding failure are categorised as surface failures and flashing issues. The failures that make up the other half of all issues recorded range from cracking, backing and mix to issues with regard to the order of construction.

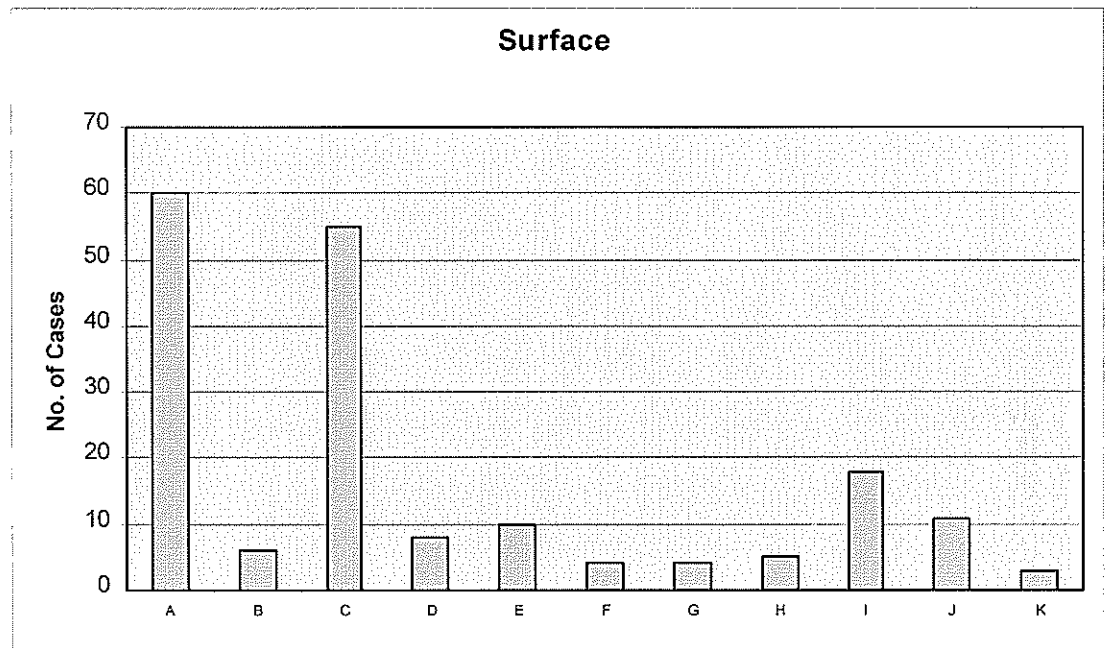
Figure 4.03 Surface breakdown

Figure 4.03 indicates the number of site visit cases which identify areas of failure in relation to the cladding surface.

A high proportion of the issues associated to Surface are from problems to do with surface sealant (paint). Major factors reported are the discolouration, staining and generally inadequate application of the paint. Other factors reported with less occurrences were related to the bubbling, blistering, peeling and the chalky/powdery nature of the surface.

Control joints, which are essential to provide adequate movement to occur in the body of a single material were reported on a number of occurrences (40) as being non-existing and lacking, while a further 14 reports noted that the current control joints provided were inadequate. The reports did not expand on their inadequacy but it is suspected that a poor depth of joint, or the spacing between the joints provided is too great.

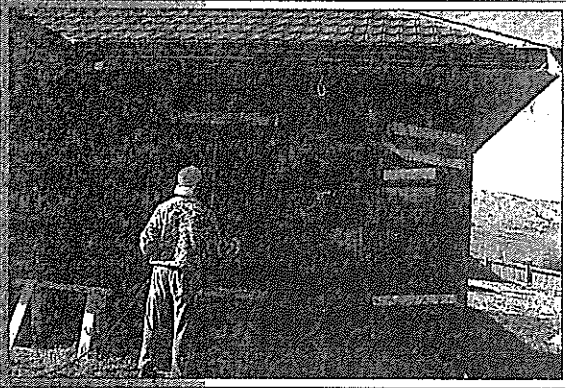
*Hosing night and morning is not enough for plaster to cure properly in summer.*
