EARTHQUAKE HAZARD CENTRE NEWSLETTER

Vol. 21 No. 1

JULY 2017

| Continuation of a Summary of the paper “Confined Masonry Buildings: The Chilean Experience” | p.3 |

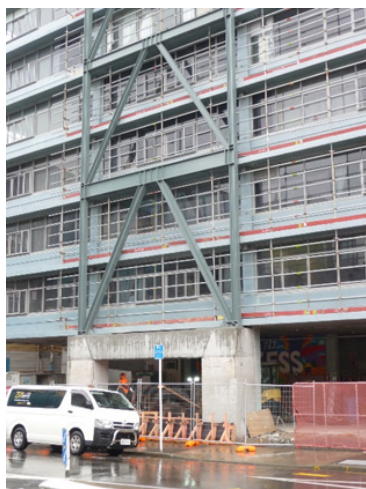
Now the retrofit project is almost complete (Figure 1).

Figure 1. One of the four perimeter lateral load resisting frames

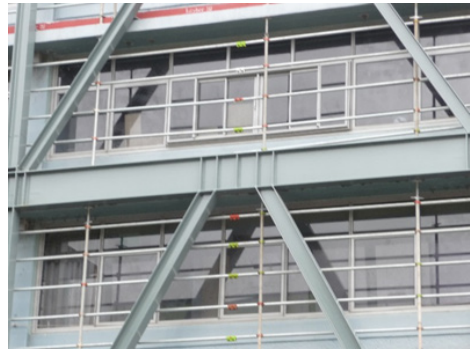
Eccentrically-braced frames are popular due to their ductility in the event of seismic overload. Figure 2 shows the region that acts as a potential seismic fuse that will be distorted during the design earthquake.

Figure 2. The short length of beam between the diagonals will be distorted when it functions as a seismic fuse.

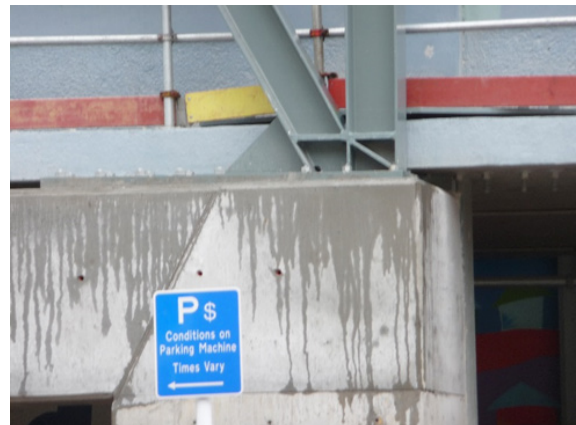
Since the structural engineer has designed seismic fuses at each beam level between the diagonals, every other part of the structure needs to be stronger so that only those fuses ever suffer damage. This means the columns on each side of the braced frame and their fixings to the RC moment frame must be stronger than the seismic fuses (Figure 3).

Figure 3. Connection between column and frame. The column is embedded the whole height of the RC column while a horizontal plate with many embedded bolts transfers horizontal forces into the diagonal brace.

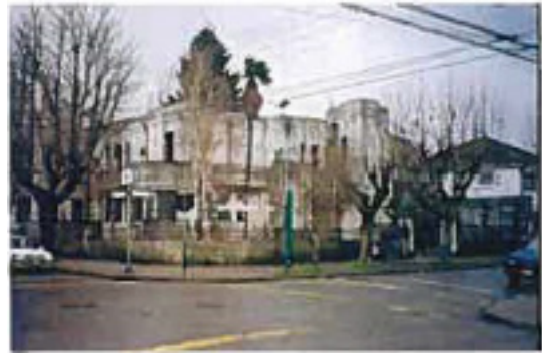
Fig. 4. Old confined masonry house currently in use in Chillán

- Out of a total of 154 dwellings, confined masonry representing 4.5% of the total housing, 83 were in good condition, 49 were damaged, 5 are currently semi-destroyed and in use and 17 were totally destroyed, i.e. 54% experienced no damage. Figure 4 shows a house of this type currently in use.

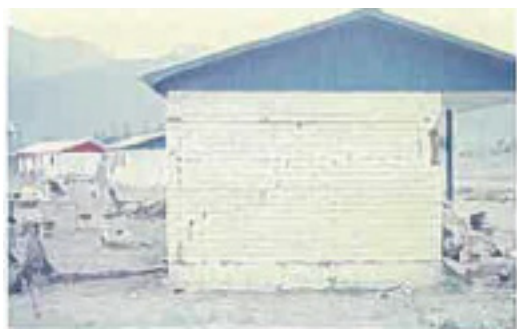
1965 La Ligua earthquake. Again, masonry houses were damaged and of particular interest was the case of the destruction of about 1,000 houses located in the valley of the Choapa River (see Figure 5). The walls of these one-story houses were built with hand-made clay bricks, reinforced at the top of the walls with RC beams and with some vertical tensile steel bars placed at the wall intersections, within holes perforated in the bricks. The effects of poor quality of soils and inappropriate design of the foundations made the damage more severe.

*Fig. 5. Observed damage during 1971
Papudo earthquake.*

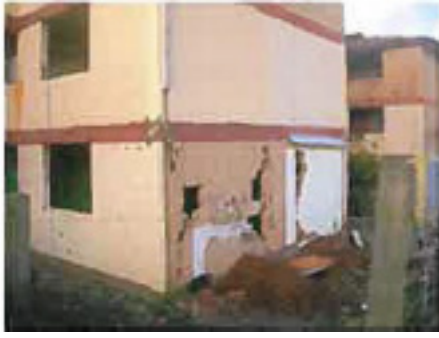
Constitución

Fig. 6. Observed damage during 2010 Maule earthquake

built in Talca in 1956. The masonry walls of these old buildings were built using hand-made solid clay bricks and a low-strength mortar (cement:lime:sand mix ratio 1:1:6). In addition, RC tie-columns were provided only at wall intersections but not around the openings, thus these old buildings can be considered as “partially confined”. Examples of severe damaged partially confined masonry buildings are shown in Figure 6.
